Advantage Inspection Service, Inc.

CONFIDENTIAL INSPECTION REPORT

4695 E. Sanna, Paradise Valley, AZ

5/18/2009 8:00 am to 11:30 am

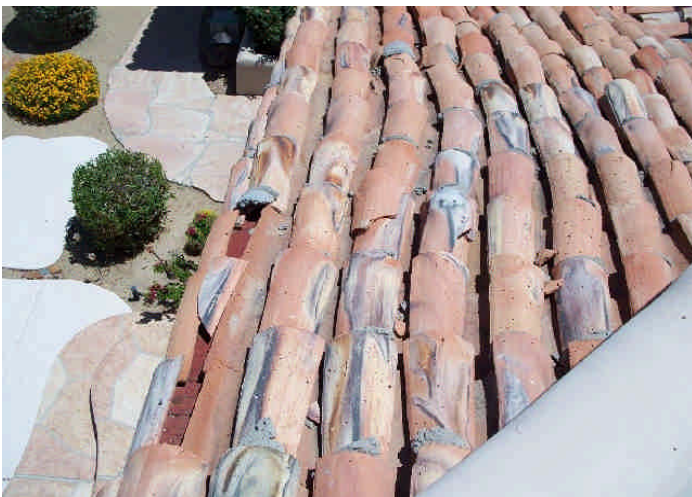
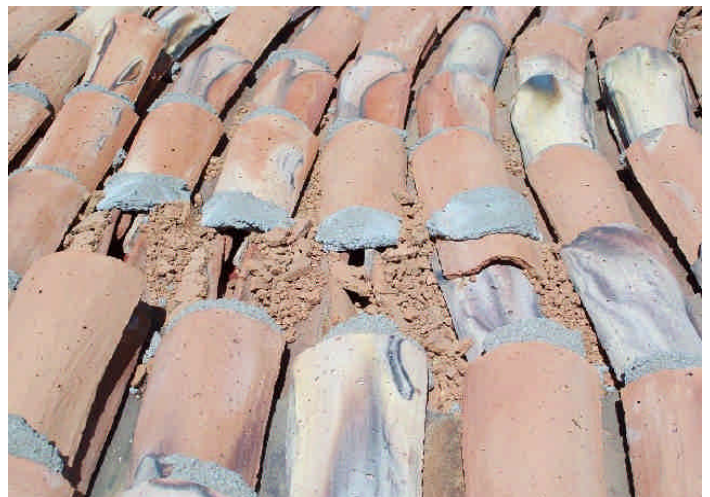
+ Maintenance and review required at tiled roof - Attention.

+ We observed approximately 30+ broken roof tiles needing replacement, further review needed - Attention.

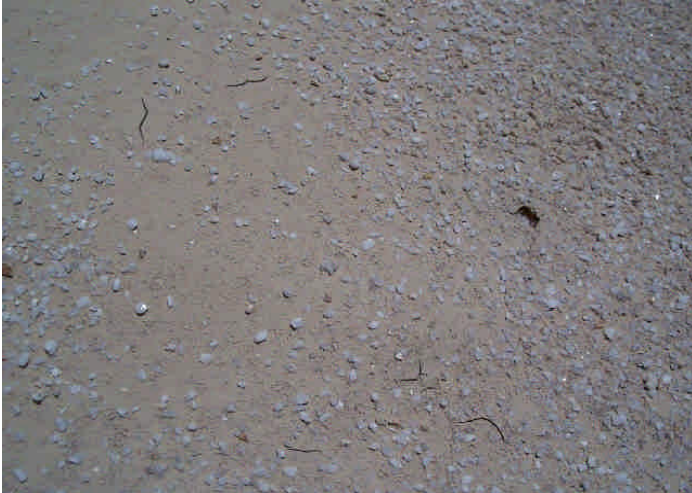
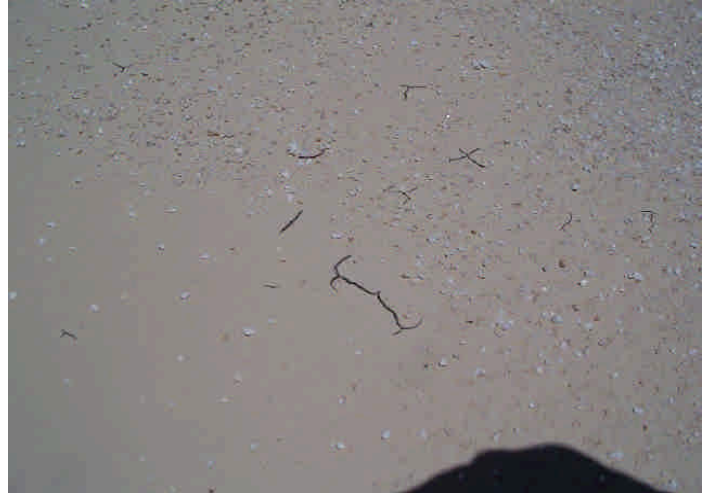
- + Prior roof patching evident - Consult Seller.
- + Maintenance and review is required at the foam roof area - Attention.
- + Cracking was observed at the coating surface, repairs needed - Attention.

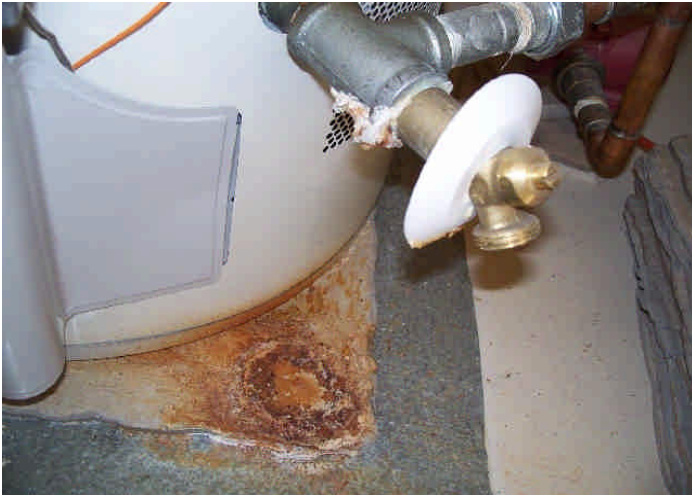
- + Corrosion noted at water heater shut off valve - Monitor.

+ Evidence of past water heater piping leaks noted - Monitor.

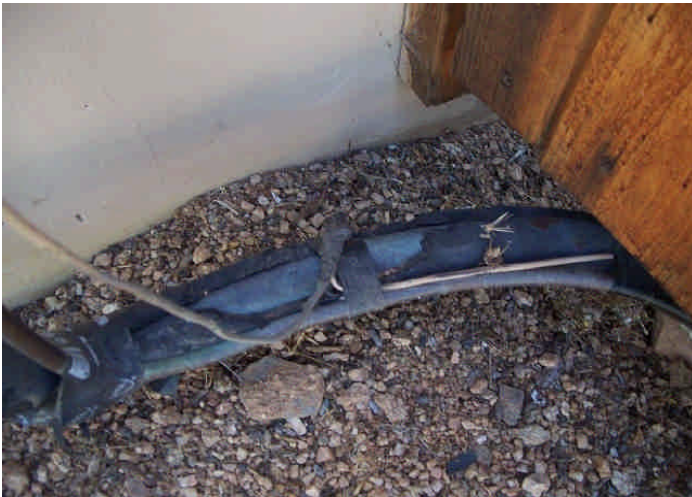
+ Insulation is damaged at the refrigerant lines of the cooling system, replace as required - Attention.

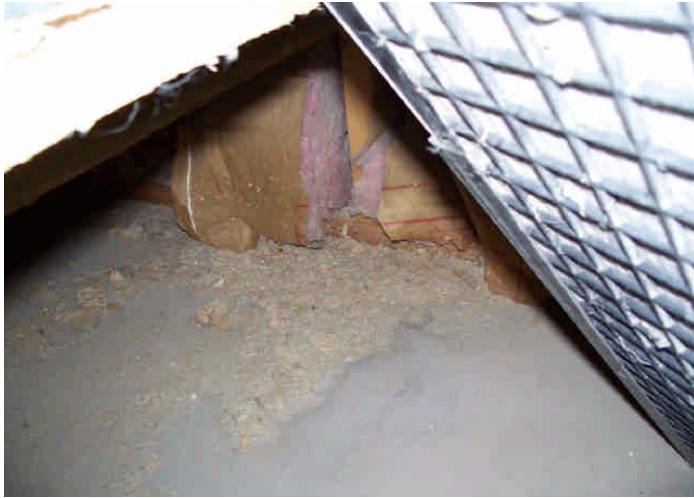
+ Dirty heating/cooling system filter(s) were noted - Attention.

+ The return-air compartment is dirty and should be serviced - Attention.

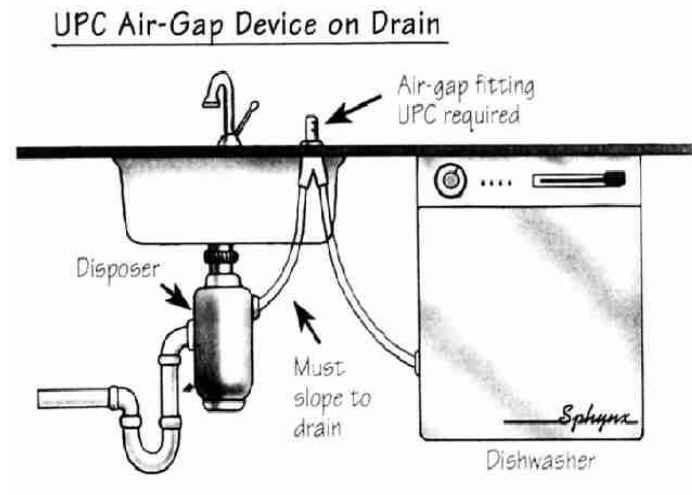
- + Dishwasher was Operational except Adverse Conditions noted - Review.
- + No air gap device or high loop is present at dishwasher drain line. This condition could allow debris to backup from the sink drain into the dishwasher and it can be easily fixed by a service technician - Attention.

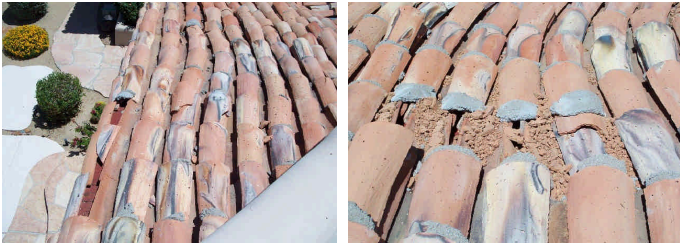
- + Maintenance and review required at tiled roof - Attention.
- + We observed approximately 30+ broken roof tiles needing replacement, further review needed - Attention.

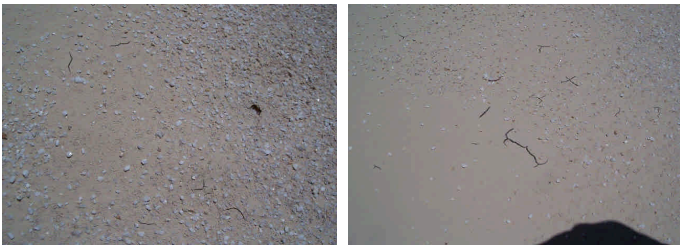
- + Maintenance and review is required at the foam roof area - Attention.
- + Cracking was observed at the coating surface, repairs needed - Attention.
